**Flood Control Project Maintenance
Levee Inspections**

Maintenance Issue Types Only, Levee Inspection Report By Mile - Fall 2015

Sacramento Maintenance Yard Cache Creek

Waterway	Bank	Unit Miles	Inspection Start/End	Inspector
Unit No. 01 North Levee	Left	11.69	10/07/2015 10/08/2015	Jai Lor

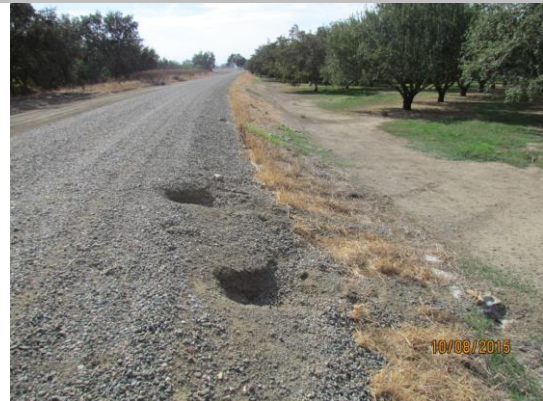
Photo 1 of 1 : FA_2015_ST0001_259_63_20151012_00078.jpg

LM Start	1.33	Rating **	M	Issue No.	63
LM End	1.33	Issue Type +	Ma	Location *	LS
Category	Earthen Levee			GPS Latitude/Longitude	
				Start	End
Item	Slope Stability			38.722302 °	38.722302 °
				-121.809424 °	-121.809424 °
DWR ID	DWR_ST0001_01_f_2015_63				
Action/Comments					
Repair the levee slope damaged by vehicle traffic and prevent access where possible.

View of the potholes created by vehicles on the landward side of the levee looking upstream. Fall 2015.

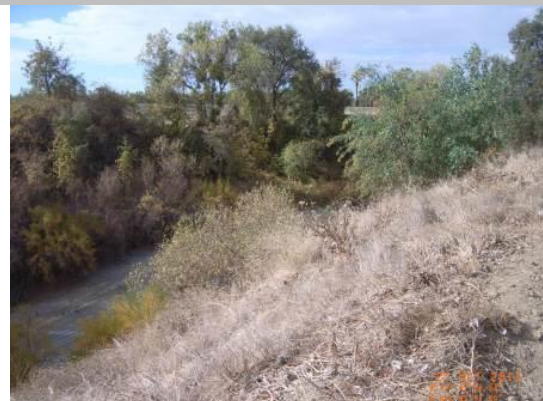
Photo 1 of 1 : USACE2013A_CHC_2-4_L_2.jpg

LM Start	2.57	Rating **	U	Issue No.	17
LM End	2.61	Issue Type +	Ma	Location *	WS
Category	Supplemental			GPS Latitude/Longitude	
				Start	End
Item	2015 USACE Erosion Survey, DRAFT			38.732836 °	38.732685 °
				-121.797893 °	-121.797154 °
DWR ID					
Action/Comments					
Inspector Comments: Site identified as CRITICAL in 2002. 2006 - Currently constructing a setback levee. New failures present and extensive. Downstream end of the setback levee did not extend far enough. Upstream end was repaired. 2007 - DWR repaired with a setback levee, but the levee did not go far enough downstream. 2012 - New cracks observed. 2013 - Fresh erosion on upper bank. 2015: No observed changes. [2015 Site ID: CHC 2-4 L]

USACE 2013 Photo #1

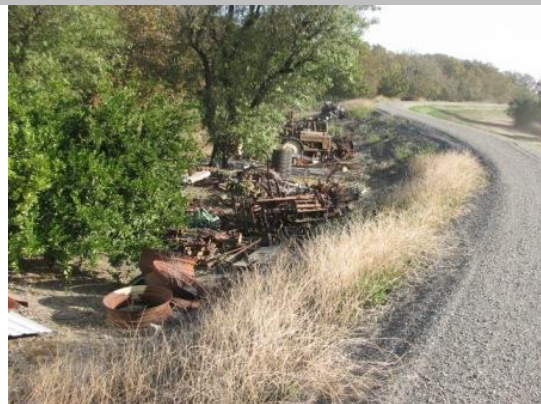
Photo 1 of 2 : FA_2015_ST0001_259_19_20150914_00017.jpg

LM Start	2.68	Rating **	M	Issue No.	19
LM End	2.72	Issue Type +	Ma	Location *	LS
Category	Earthen Levee			GPS Latitude/Longitude	
				Start	End
Item	Encroachments			38.733080 °	38.733492 °
				-121.796013 °	-121.795293 °
DWR ID	DWR_ST0001_01_s_2012_19				
Action/Comments					
Equipment

The equipment is stored at the toe of the levee. Fall 2011

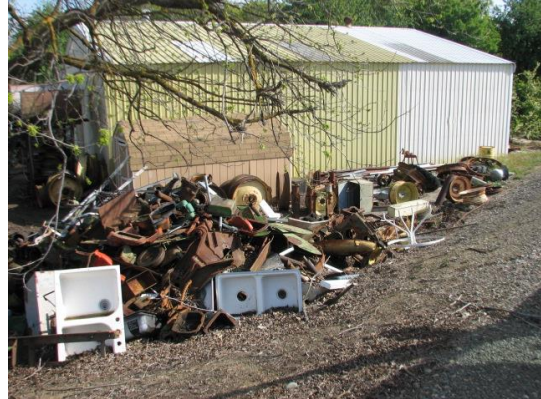
Photo 2 of 2 : FA_2015_ST0001_259_19_20150914_00018.jpg

LM Start	2.68	Rating **	M	Issue No.	19 (cont)
LM End	2.72	Issue Type +	Ma	Location *	LS
Category	Earthen Levee			GPS Latitude/Longitude	
				Start	End
Item	Encroachments			38.733080 °	38.733492 °
				-121.796013 °	-121.795293 °
DWR ID	DWR_ST0001_01_s_2012_19				
Action/Comments					
Equipment

Equipment and parts stacked along the levee toe and slope. Spring 2014

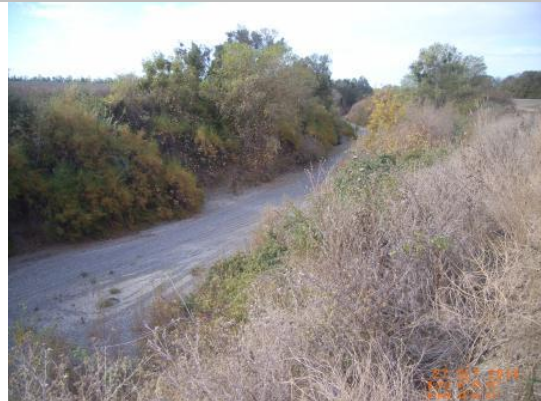
Photo 1 of 1 : USACE2013A_CHC_2-8_L_2.jpg

LM Start	2.82	Rating **	M	Issue No.	38
LM End	2.86	Issue Type +	Ma	Location *	WS
Category	Supplemental			GPS Latitude/Longitude	
				Start	End
Item	2015 USACE Erosion Survey, DRAFT			38.734067 °	38.734171 °
				-121.793713 °	-121.792992 °
DWR ID					
Action/Comments					
Inspector Comments: 2006 - Large new failure. 2008 - Plans for repair currently in the design phase. 2010 - Planned setback levee by CA DWR, 60% design complete, construction planned for 2012. 2011 - Construction delayed to 2013 - 2014. 2015: No observed changes. [2015 Site ID: CHC_2-8_L]

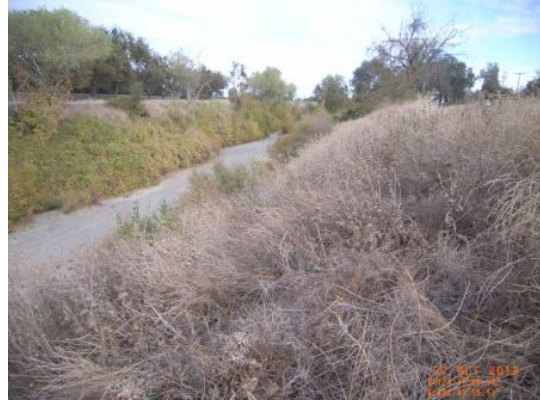
Photo 1 of 1 : USACE2013A_CHC_3-4_L_6.jpg

LM Start	3.48	Rating **	M	Issue No.	1
LM End	3.57	Issue Type +	Ma	Location *	WS
Category	Supplemental			GPS Latitude/Longitude	
				Start	End
Item	2015 USACE Erosion Survey, DRAFT			38.732942 °	38.731626 °
				-121.784965 °	-121.785231 °
DWR ID					
Action/Comments					
Inspector Comments: 2006 - Some significant new erosion, especially fresh upper bank slumping. Still substantial berm. 2010 - Site extended downstream, some new erosion, heavily vegetated and hard to see. Planned setback levee by CA DWR, 60% design complete, construction planned for 2012. 2011 - Construction delayed to 2013 - 2014. 2015: No observed changes. [2015 Site ID: CHC_3-4_L]

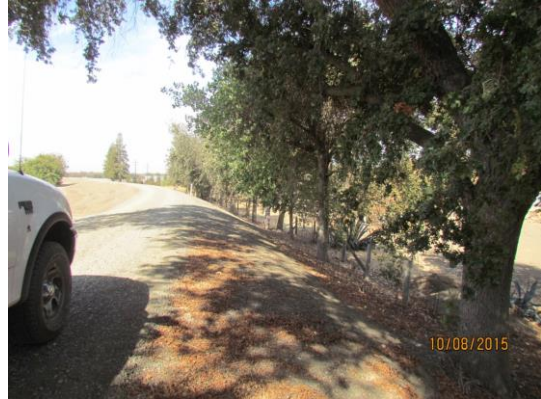
Photo 1 of 1 : FA_2015_ST0001_259_27_20151012_00059.jpg

LM Start	4.28	Rating **	M	Issue No.	27
LM End	4.43	Issue Type +	Ma	Location *	LS
Category	Earthen Levee			GPS Latitude/Longitude	
				Start	End
Item	Vegetation			38.727047 °	38.726113 °
				-121.774413 °	-121.771929 °
DWR ID	DWR_ST0001_01_s_2012_27				
Action/Comments					
Landscaping

View of the landscape trees on the landward side of the levee looking upstream. Fall 2015.

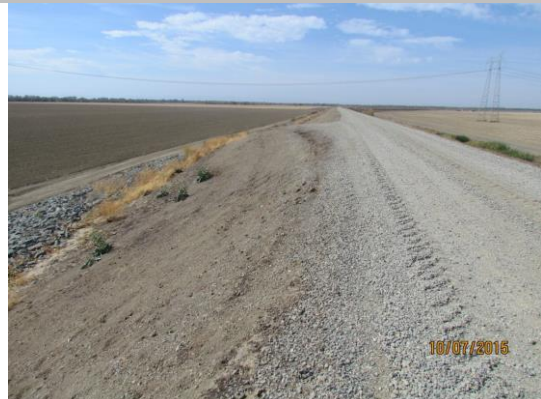
Photo 1 of 1 : FA_2015_ST0001_259_23_20151012_00037.jpg

LM Start	5.71	Rating **	A	Issue No.	23
LM End	11.69	Issue Type +	Ma	Location *	WS
Category	Earthen Levee			GPS Latitude/Longitude	
				Start	End
Item	Vegetation			38.723660 °	38.698622 °
				-121.755130 °	-121.674202 °
DWR ID	DWR_ST0001_01_f_2015_23				
Action/Comments					
Control annual grass and weeds on the levee slopes and easements. Inspector Comments: The LMA has burned and dragged the levee.

View of the vegetation on the waterward side of the levee looking upstream taken at levee mile 11.69. Fall 2015.

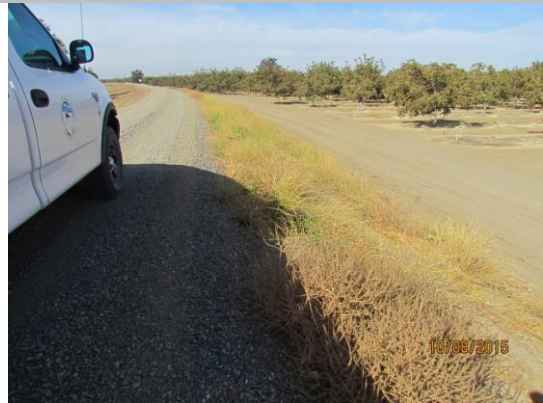
Photo 1 of 1 : FA_2015_ST0001_259_52_20151012_00054.jpg

LM Start	6.52	Rating **	M	Issue No.	52
LM End	6.56	Issue Type +	Ma	Location *	LS
Category	Earthen Levee			GPS Latitude/Longitude	
				Start	End
Item	Vegetation			38.728824 °	38.728858 °
				-121.742494 °	-121.741821 °
DWR ID	DWR_ST0001_01_f_2015_52				
Action/Comments					
Control annual grass and weeds on the levee slopes and easements.

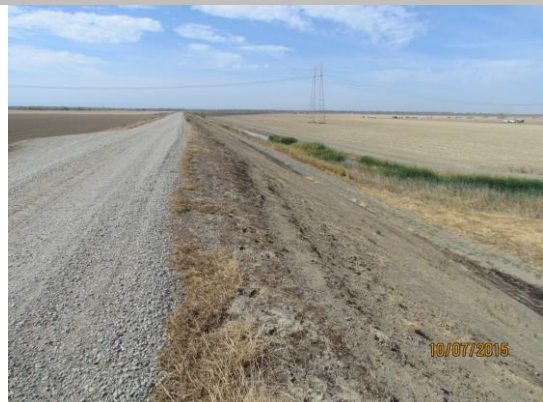
Photo 1 of 1 : FA_2015_ST0001_259_22_20151012_00038.jpg

LM Start	6.56	Rating **	A	Issue No.	22
LM End	11.69	Issue Type +	Ma	Location *	LS
Category	Earthen Levee			GPS Latitude/Longitude	
				Start	End
Item	Vegetation			38.728859 °	38.698622 °
				-121.741821 °	-121.674202 °
DWR ID	DWR_ST0001_01_f_2015_22				
Action/Comments					
Control annual grass and weeds on the levee slopes and easements. Inspector Comments: The LMA has burned and dragged the levee.

View of the vegetation on the landward side of the levee looking upstream taken at levee mile 11.69. Fall 2015.

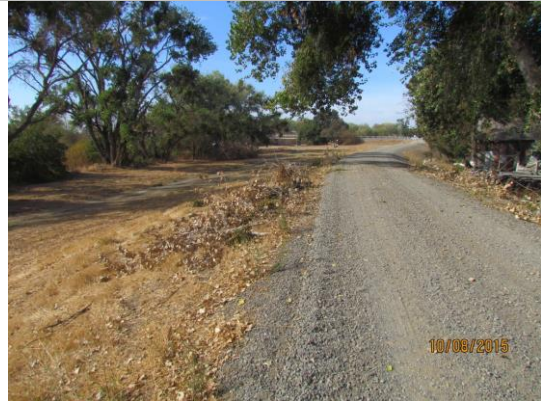
Photo 1 of 1 : FA_2015_ST0001_259_56_20151012_00049.jpg

LM Start	7.34	Rating **	M	Issue No.	56
LM End	7.34	Issue Type +	Ma	Location *	WS
Category	Earthen Levee			GPS Latitude/Longitude	
				Start	End
Item	Encroachments			38.728025 °	38.728025 °
				-121.727829 °	-121.727829 °
DWR ID	DWR_ST0001_01_f_2015_56				
Action/Comments					
Tree or limb

View of the broken tree branches on the waterward side of the levee looking upstream. Fall 2015.

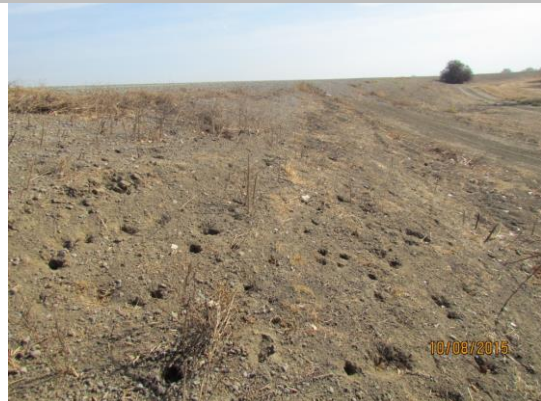
Photo 1 of 1 : FA_2015_ST0001_259_54_20151012_00048.jpg

LM Start	7.60	Rating **	M	Issue No.	54
LM End	7.60	Issue Type +	Ma	Location *	WS
Category	Earthen Levee			GPS Latitude/Longitude	
				Start	End
Item	Animal Control			38.729218 °	38.729218 °
				-121.723325 °	-121.723325 °
DWR ID	DWR_ST0001_01_f_2015_54				
Action/Comments					
No rodents visible, but rodent burrows visible; need to backfill and compact or grout burrows.

View of the rodent holes on the waterward side of the levee looking downstream. Fall 2015.

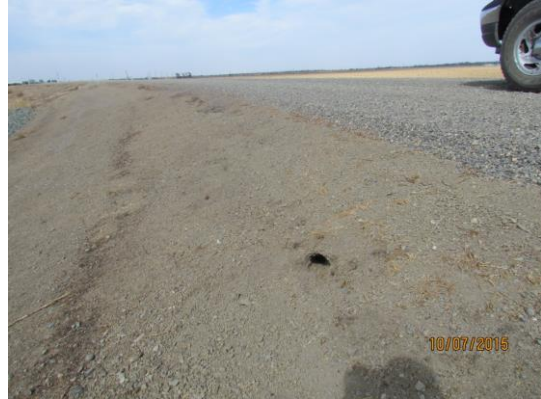
Photo 1 of 2 : FA_2015_ST0001_259_37_20151012_00040.jpg

LM Start	9.38	Rating **	M	Issue No.	37
LM End	9.38	Issue Type +	Ma	Location *	WS
Category	Earthen Levee			GPS Latitude/Longitude	
				Start	End
Item	Animal Control			38.719392 °	38.719392 °
				-121.696879 °	-121.696879 °
DWR ID	DWR_ST0001_01_f_2015_37				
Action/Comments					
No rodents visible, but rodent burrows visible; need to backfill and compact or grout burrows.

View of the rodent hole on the waterward side of the levee looking upstream. Fall 2015.

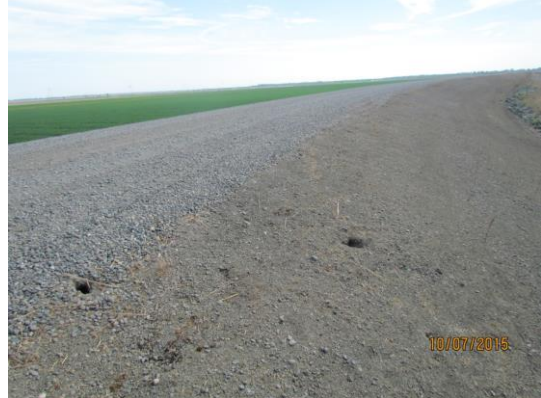
Photo 2 of 2 : FA_2015_ST0001_259_37_20151012_00042.jpg

LM Start	9.38	Rating **	M	Issue No.	37 (cont)
LM End	9.38	Issue Type +	Ma	Location *	WS

View of the rodent hole on the waterward side of the levee looking downstream. Fall 2015.

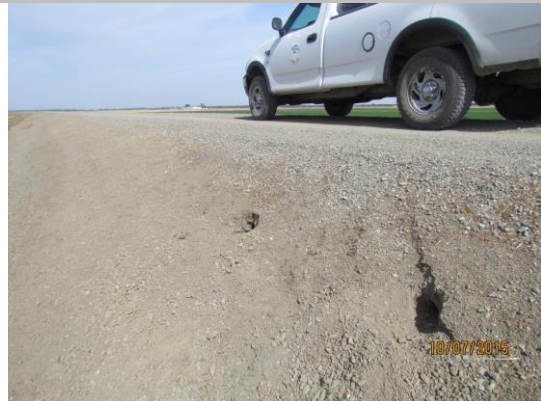
Photo 1 of 1 : FA_2015_ST0001_259_35_20151012_00039.jpg

LM Start	9.72	Rating **	M	Issue No.	35
LM End	9.72	Issue Type +	Ma	Location *	WS
Category	Earthen Levee			GPS Latitude/Longitude	
				Start	End
Item	Animal Control			38.714413 °	38.714413 °
				-121.697168 °	-121.697168 °
DWR ID	DWR_ST0001_01_f_2015_35				
Action/Comments					
No rodents visible, but rodent burrows visible; need to backfill and compact or grout burrows.

View of the rodent hole on the waterward side of the levee looking upstream. Fall 2015.

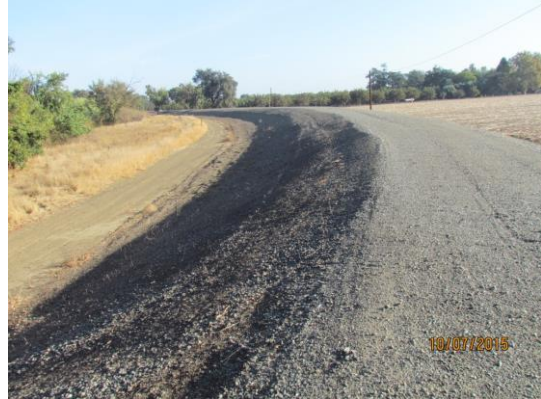
Photo 1 of 1 : FA_2015_ST0001_260_5_20151012_00020.jpg

LM Start	0.01	Rating **	A	Issue No.	5
LM End	11.47	Issue Type +	Ma	Location *	WS
Category	Earthen Levee			GPS Latitude/Longitude	
				Start	End
Item	Vegetation			38.727240 °	38.678067 °
				-121.806270 °	-121.673114 °
DWR ID	DWR_ST0001_02_f_2015_5				
Action/Comments					
Control annual grass and weeds on the levee slopes and easements. Inspector Comments: LMA has burned and dragged the levee.

View of the vegetation on the waterward side of the levee looking downstream. Fall 2015.

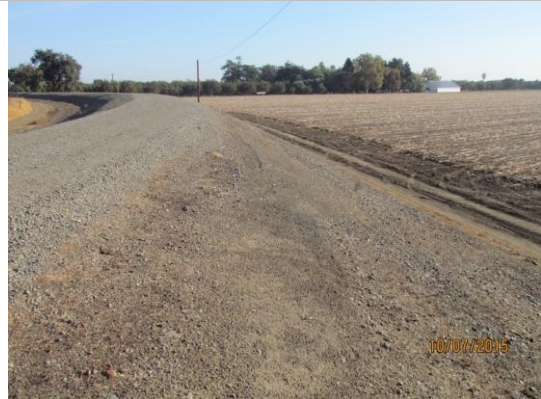
Photo 1 of 1 : FA_2015_ST0001_260_4_20151012_00019.jpg

LM Start	0.01	Rating **	A	Issue No.	4
LM End	11.47	Issue Type +	Ma	Location *	LS
Category	Earthen Levee			GPS Latitude/Longitude	
				Start	End
Item	Vegetation			38.727243 °	38.678067 °
				-121.806253 °	-121.673114 °
DWR ID	DWR_ST0001_02_f_2015_4				
Action/Comments					
Control annual grass and weeds on the levee slopes and easements. Inspector Comments: LMA has burned and dragged the levee.

View of the vegetation on the landward side of the levee looking downstream. Fall 2015.

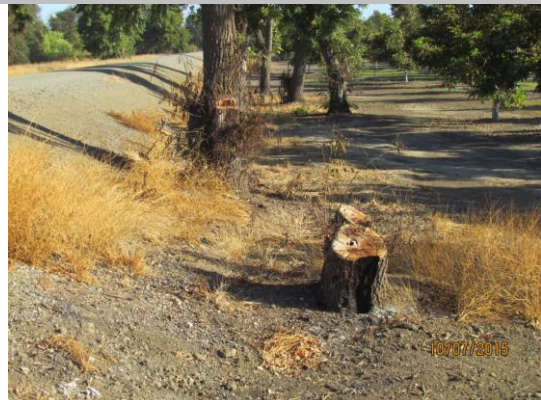
Photo 1 of 1 : FA_2015_ST0001_260_10_20151012_00021.jpg

LM Start	0.18	Rating **	N	Issue No.	10
LM End	0.18	Issue Type +	Ma	Location *	LS
Category	Earthen Levee			GPS Latitude/Longitude	
				Start	End
Item	Trim / Thin Trees			38.729560 °	38.729560 °
				-121.805231 °	-121.805231 °
DWR ID	DWR_ST0001_02_f_2015_10				
Action/Comments					
Tree stumps.					
Inspector Comments: The stump is located at the levee toe.

View of the tree stump at the landward side of the levee looking downstream. Fall 2015.

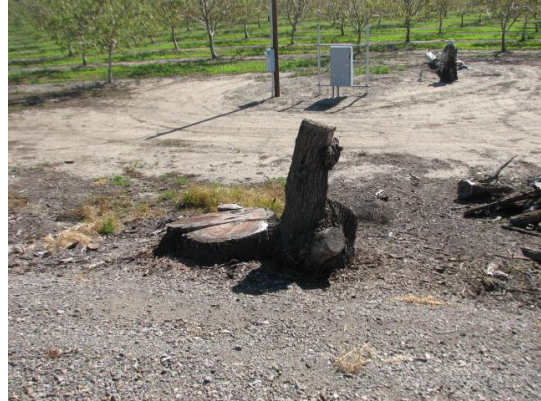
Photo 1 of 1 : FA_2015_ST0001_260_6_20150914_00004.jpg

A large black walnut tree stump is at the toe of the levee. Spring 2014

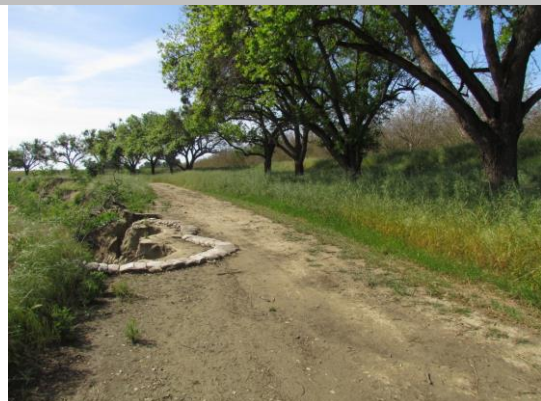
Photo 1 of 2 : FA_2015_ST0001_260_11_20150914_00008.jpg

The view of the erosion from a distance. Spring 2015.

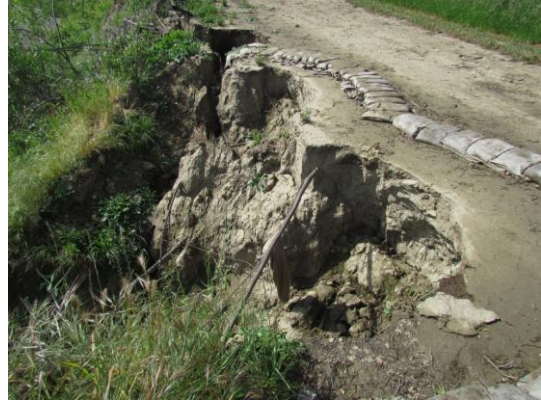
Photo 2 of 2 : FA_2015_ST0001_260_11_20150914_00009.jpg

View of the erosion on the channel looking downstream. Spring 2015.

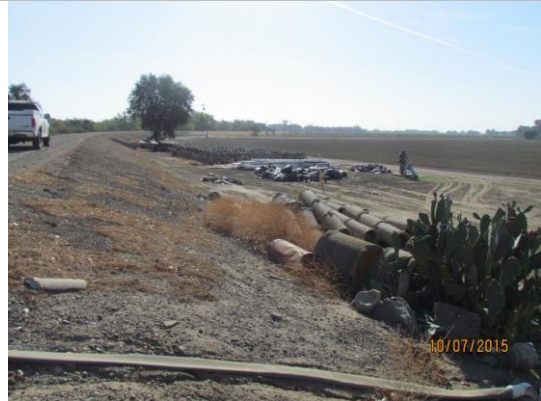
Photo 1 of 1 : FA_2015_ST0001_260_3_20151012_00024.jpg

View of the concrete pile at the toe of the landward side of the levee looking downstream. Fall 2015.

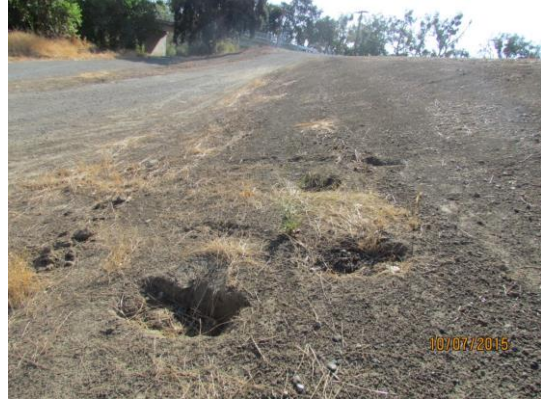
Photo 1 of 1 : FA_2015_ST0001_260_21_20151012_00028.jpg

LM Start	3.06	Rating **	M	Issue No.	21
LM End	3.06	Issue Type +	Ma	Location *	WS
Category	Earthen Levee			GPS Latitude/Longitude	
				Start	End
Item	Slope Stability			38.720565 °	38.720565
				-121.765306 °	-121.765306
DWR ID	DWR_ST0001_02_f_2015_21				
Action/Comments					
Repair the levee slope damaged by vehicle traffic and prevent access where possible.

View of the potholes created from vehicles on the waterward side of the levee looking downstream. Fall 2015.

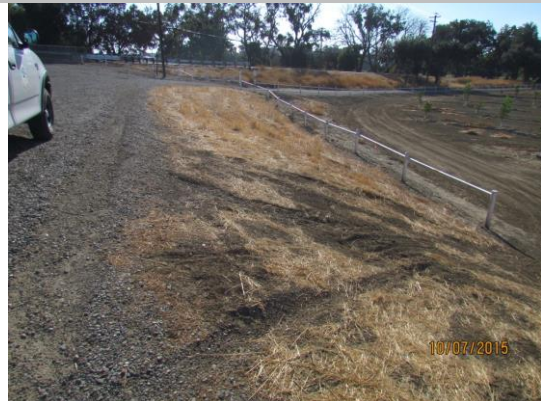
Photo 1 of 1 : FA_2015_ST0001_260_20_20151012_00027.jpg

LM Start	3.07	Rating **	A/W	Issue No.	20
LM End	3.07	Issue Type +	Ma	Location *	LS
Category	Earthen Levee			GPS Latitude/Longitude	
				Start	End
Item	Slope Stability			38.720466 °	38.720466 °
				-121.765027 °	-121.765027 °
DWR ID	DWR_ST0001_02_f_2015_20				
Action/Comments					
Repair the levee slope damaged by vehicle traffic and prevent access where possible.					
Inspector Comments: Suggest monitoring the slopes in the area for slope damage due to vehicle access.

View of the slope stability caused by vehicles on the landward side of the levee looking downstream. Fall 2015.

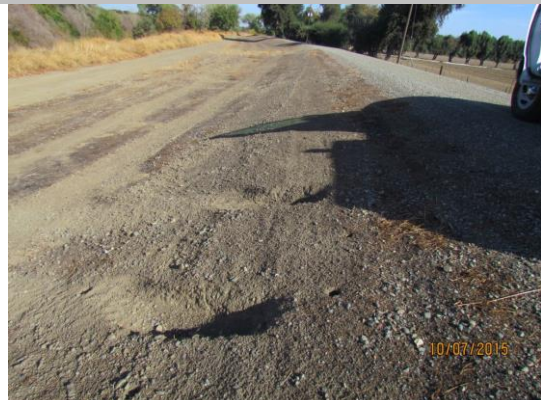
Photo 1 of 1 : FA_2015_ST0001_260_22_20151012_00029.jpg

LM Start	3.44	Rating **	M	Issue No.	22
LM End	3.44	Issue Type +	Ma	Location *	WS
Category	Earthen Levee			GPS Latitude/Longitude	
				Start	End
Item	Slope Stability			38.720862 °	38.720862 °
				-121.759540 °	-121.759540 °
DWR ID	DWR_ST0001_02_f_2015_22				
Action/Comments					
Repair the levee slope damaged by vehicle traffic and prevent access where possible.

View of the potholes created by vehicle access on the waterward side of the levee looking downstream. Fall 2015.

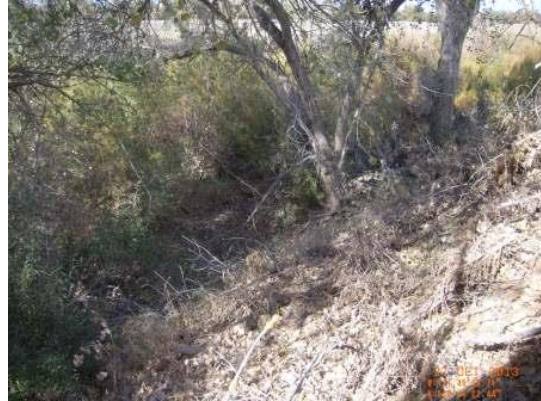
Photo 1 of 1 : USACE2013A_CHC_3-5_R_7.jpg

LM Start	3.53	Rating **	M	Issue No.	2
LM End	3.60	Issue Type +	Ma	Location *	WS
Category	Supplemental			GPS Latitude/Longitude	
				Start	End
Item	2015 USACE Erosion Survey, DRAFT			38.722138 °	38.723294 °
				-121.759736 °	-121.759588 °
DWR ID					
Action/Comments					
Inspector Comments: 2010 - Large slump on the upper berm, a tree has recently slid down the slope. 2011 - Large slump and new erosion. 2012 - Slightly steeper slopes and cracks observed. 2015: No observed changes. [2015 Site ID: CHC_3-5_R]

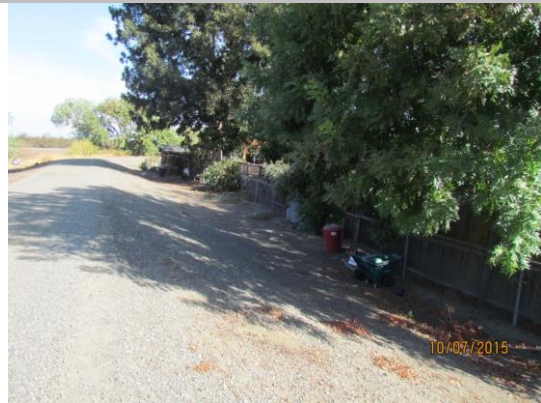
Photo 1 of 1 : FA_2015_ST0001_260_7_20151012_00030.jpg

LM Start	3.53	Rating **	A/W	Issue No.	7
LM End	3.62	Issue Type +	Ma	Location *	LS
Category	Earthen Levee			GPS Latitude/Longitude	
				Start	End
Item	Vegetation			38.722228 °	38.723322 °
				-121.759663 °	-121.759317 °
DWR ID	DWR_ST0001_02_s_2012_7				
Action/Comments					
Landscaping

View of the landscaping and fence on the landward side of the levee looking downstream. Fall 2015.

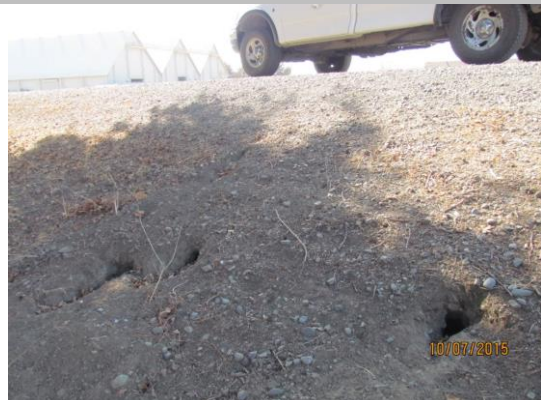
Photo 1 of 1 : FA_2015_ST0001_260_23_20151012_00033.jpg

LM Start	3.85	Rating **	M	Issue No.	23
LM End	3.85	Issue Type +	Ma	Location *	WS
Category	Earthen Levee			GPS Latitude/Longitude	
				Start	End
Item	Animal Control			38.722583 °	38.722583
				-121.755458 °	-121.755458
DWR ID	DWR_ST0001_02_f_2015_23				
Action/Comments					
No rodents visible, but rodent burrows visible; need to backfill and compact or grout burrows.

View of the animal holes on the waterward side of the levee. Fall 2015.

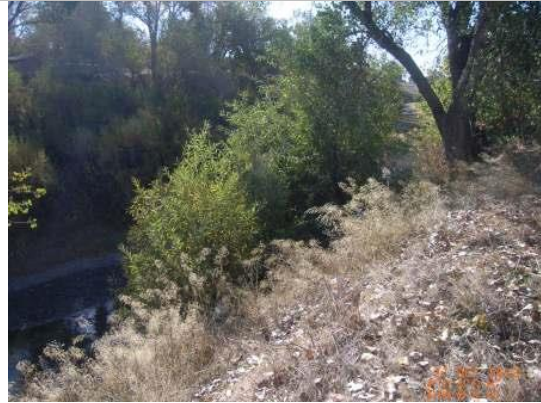
Photo 1 of 1 : USACE2013A_CHC_5-4_L_2.jpg

Action/Comments
Inspector Comments: 2009 - Erosion into the levee slope. 2010 - Minor new erosion. 2011 - New erosion and a freshly fallen tree. 2012 - New animal holes and slightly steeper slopes. 2013 - New tree popout and 2 feet of erosion along the top bank. 2015: No observed changes. [2015 Site ID: CHC_5-4_L]

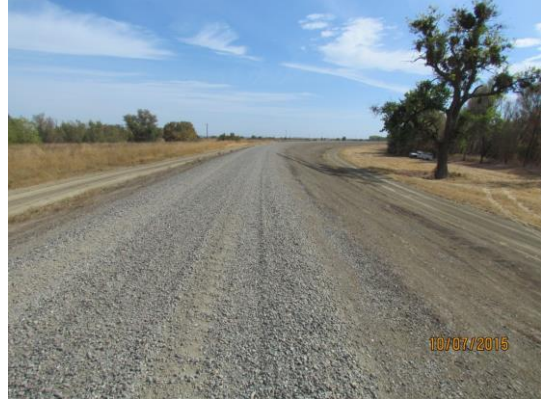
Photo 1 of 1 : FA_2015_ST0001_261_2_20151012_00002.jpg

LM Start	0.00	Rating **	A	Issue No.	2
LM End	2.25	Issue Type +	Ma	Location *	WS
Category	Earthen Levee			GPS Latitude/Longitude	
				Start	End
Item	Vegetation			38.727221 °	38.695528 °
				-121.718294 °	-121.715918 °
DWR ID	DWR_ST0001_04_f_2015_2				
Action/Comments					
Control annual grass and weeds on the levee slopes and easements. Inspector Comments: The LMA has burned and dragged the levee.

View of the vegetation on the waterward side of the levee looking downstream. Fall 2015.

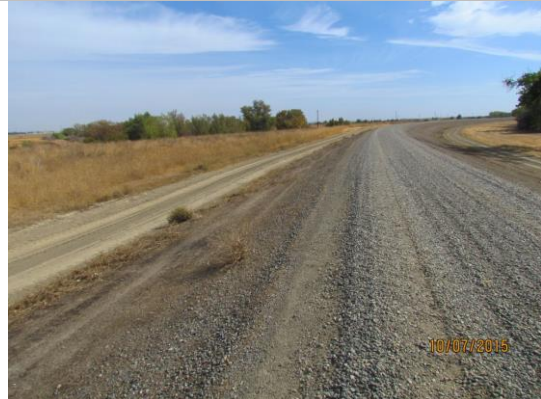
Photo 1 of 1 : FA_2015_ST0001_261_1_20151012_00001.jpg

LM Start	0.00	Rating **	A	Issue No.	1
LM End	2.25	Issue Type +	Ma	Location *	LS
Category	Earthen Levee			GPS Latitude/Longitude	
				Start	End
Item	Vegetation			38.727220 °	38.695528 °
				-121.718294 °	-121.715918 °
DWR ID	DWR_ST0001_04_f_2015_1				
Action/Comments					
Control annual grass and weeds on the levee slopes and easements. Inspector Comments: The LMA has burned and dragged the levee.

View of the vegetation on the landward side of the levee looking downstream. Fall 2015.
